# How a Turf Reduction Saves Water

**Location: Glendora Country Club, Glendora, California**

## CASE STUDY

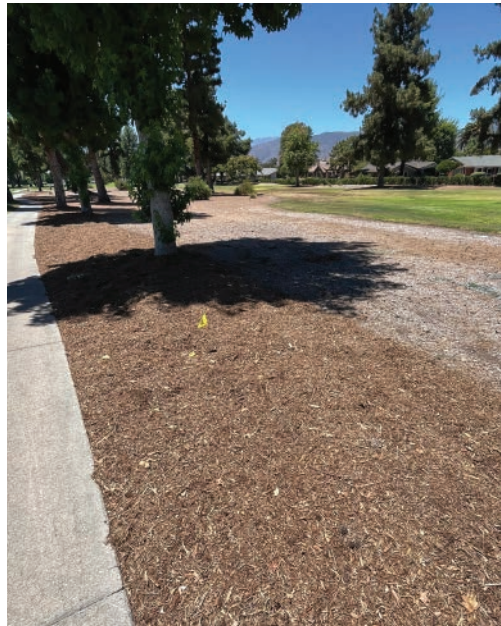
- The process involved spraying the turf removal areas with a nonselective herbicide, stripping the turf, spraying any regrowth with nonselective herbicide, then installing drip irrigation and plants. The last step was to spread wood mulch over the turf removal areas (known as “Drought-Tolerant Areas” or DTAs as they are called at Glendora). A local landscape contracting company did the turf removal, disposal, irrigation, planting, and mulching.
